CEQA and NEPA Support

Rockville Trails Estates EIR, Cordelia, Solano County, California

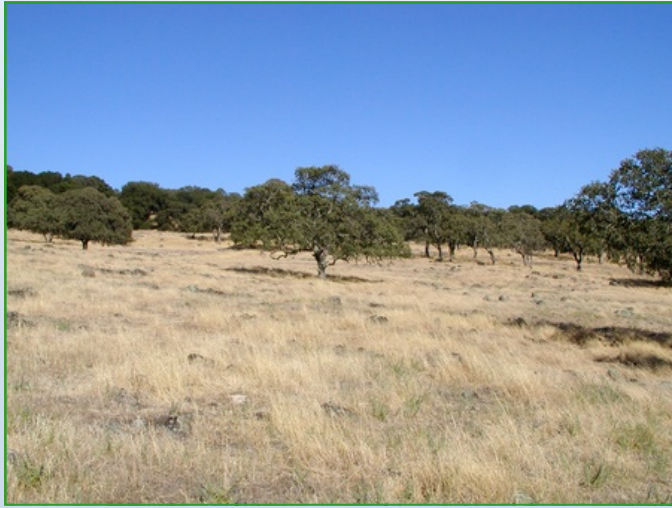
Fractured volcanic bedrock promotes rainfall infiltration.

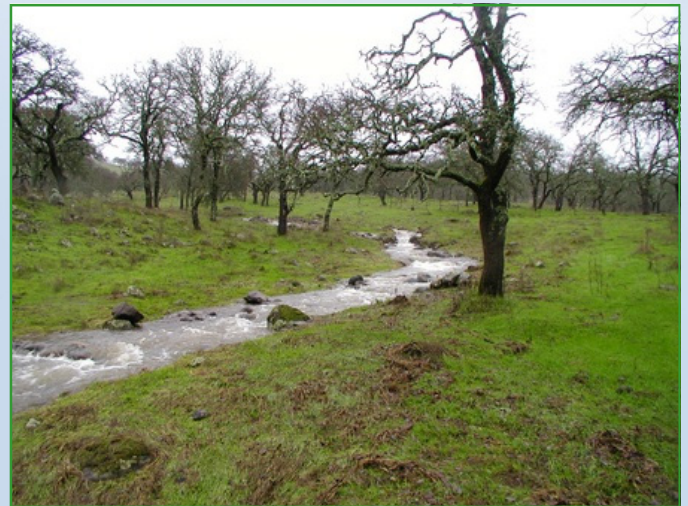
Actual runoff is lower than predicted by standard models.

- Installed two stream gages and monitored them during several spring storms to develop a calibrated HEC-HMS model
- Measured peak discharges were about one-tenth of those expected from default County-approved models, establishing that actual infiltration is higher than modeled infiltration
- Recommended use of distributed BMPs to manage peak flows and avoid hydromodification, rather than on-line detention basins, consistent with Solano County NPDES Phase 2 permit requirements
- Recommended use of lot- and neighborhood-level BMPs to promote stormwater runoff infiltration and renovation
- Results were also used to estimate recharge rates, develop a water-quality protection program for the local aquifer, and select the location of water-supply wells for the project

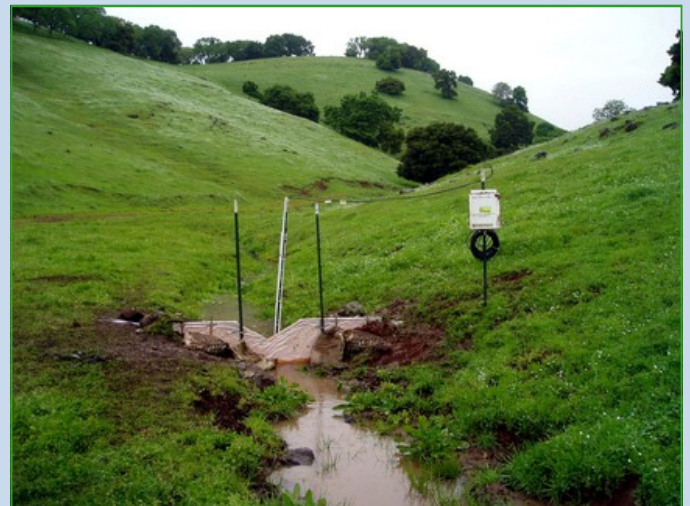
Using stream gaging to calibrate model output.
