Watershed Management

Geomorphic and Sediment Assessment of the Gazos Creek Watershed, San Mateo and Santa Cruz Counties, California

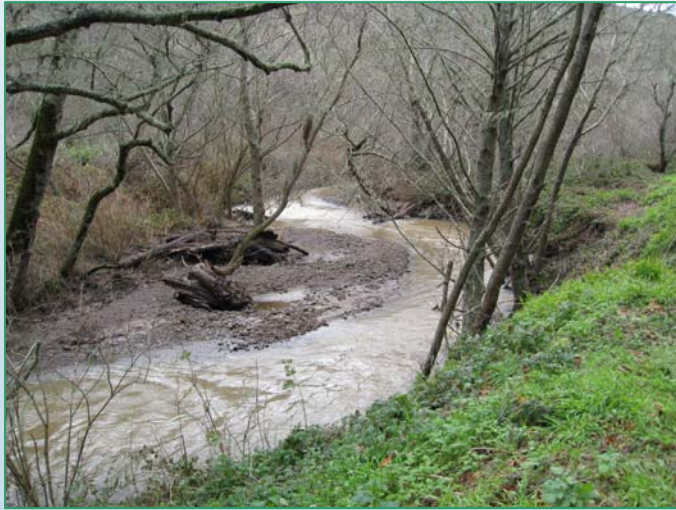
Sediment deposition in channel

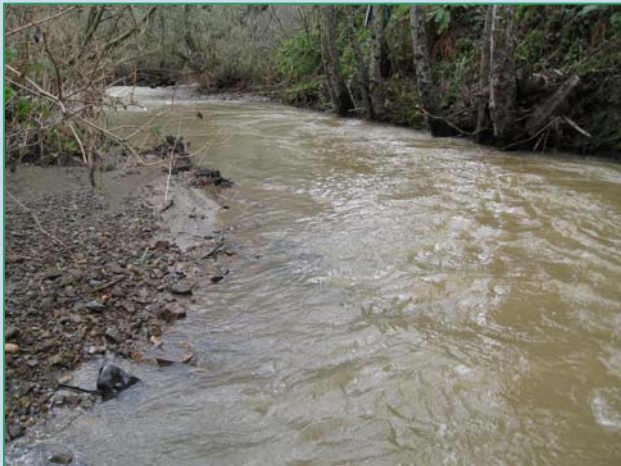
Sediment transport
