## Stream Restoration

### *Sheehy Creek Restoration, Napa County, California*

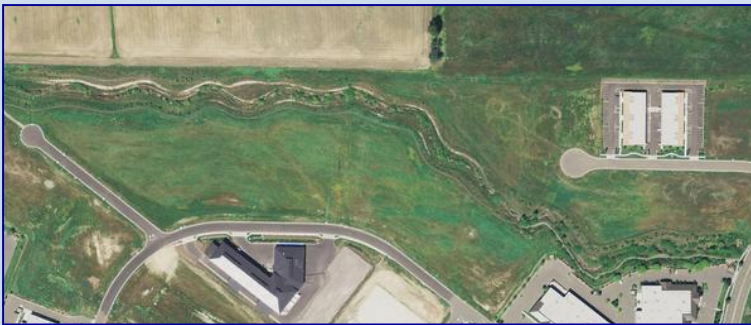
Restoration extends upstream and downstream from this central section of Sheehy Creek.

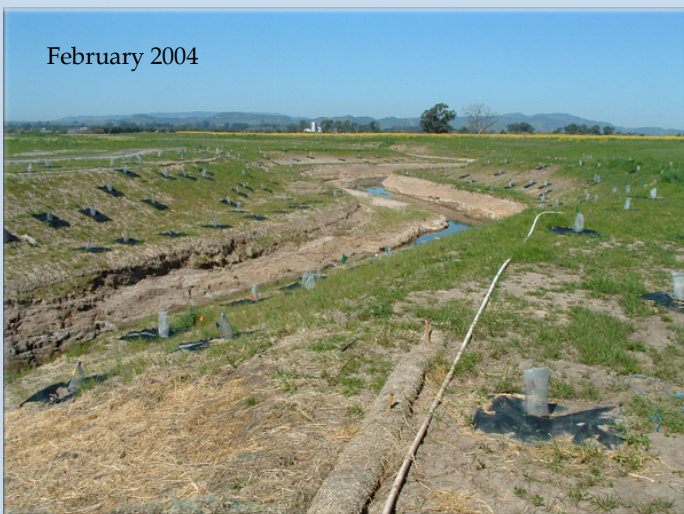
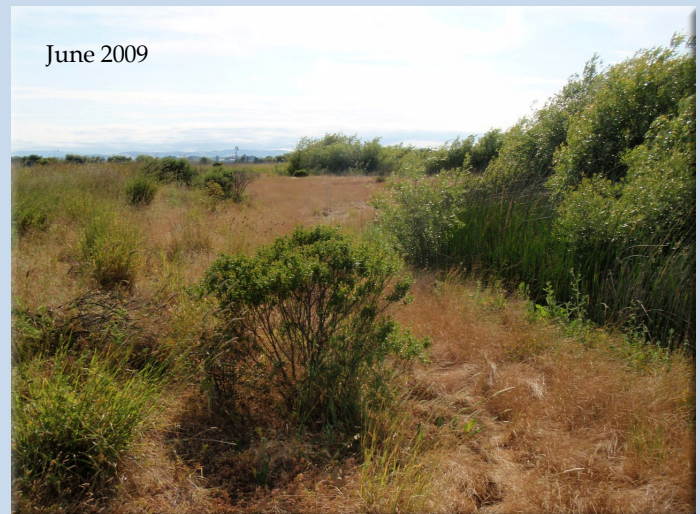
— On the upper section of Sheehy Creek, Balance's design called for removal of the upper portions of steep, incised stream banks to create broad floodplains on both sides of the creek, while leaving the central channel intact. Several years of post-project monitoring have confirmed that the central channel just overflows onto the floodplain during 1.5 to 2-year floods.

— On the lower section of Sheehy Creek, we relocated the channel from its previous incised location into a multi-stage meandering channel, including a wetland "delta" complex at the creek's mouth, where the stream flows onto the Napa River floodplain.
